REPORT OF MARINE SURVEY

CONDITION AND VALUATION SURVEY

1997 BLUEWATER YACHT 680 CUSTOM SERIES

“EXPENSIVE HABIT”

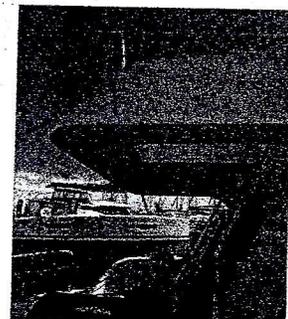
BOTTOM PAINT: *Bottom paint was showing age of product and requires refinishing.

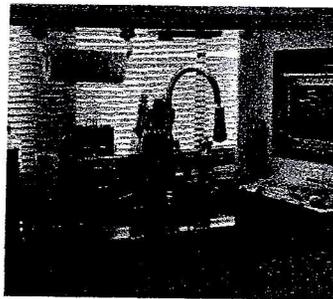
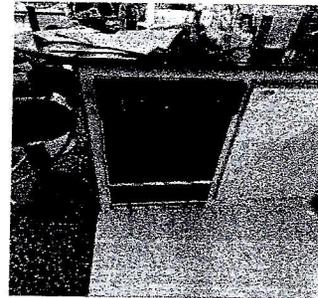
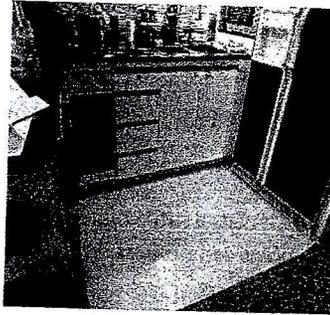
Galley: Galley is located to starboard, aft salon. Equipped with a dual stainless sink.

All appliances, dishwasher, refrigerator, trash compactor and 4 burner electric range appear to be original and in non-operating condition reported by owner.

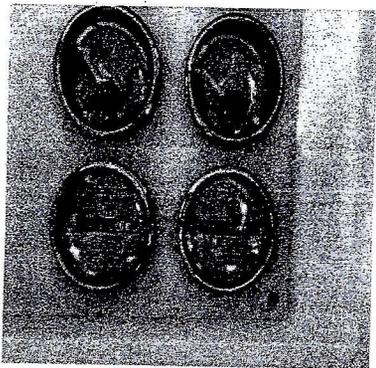
Engine hours displayed: Port: 1010.40 Starboard: 1013.45

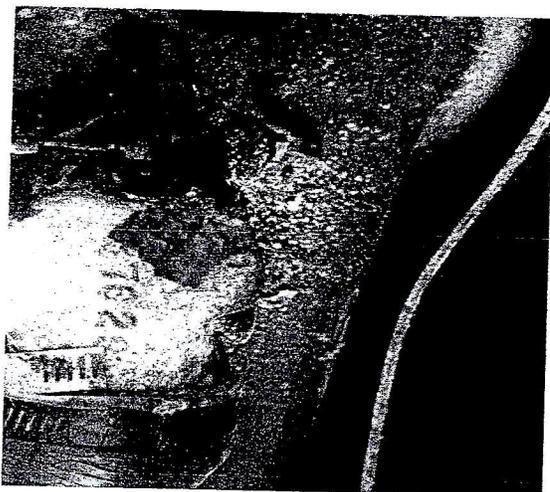
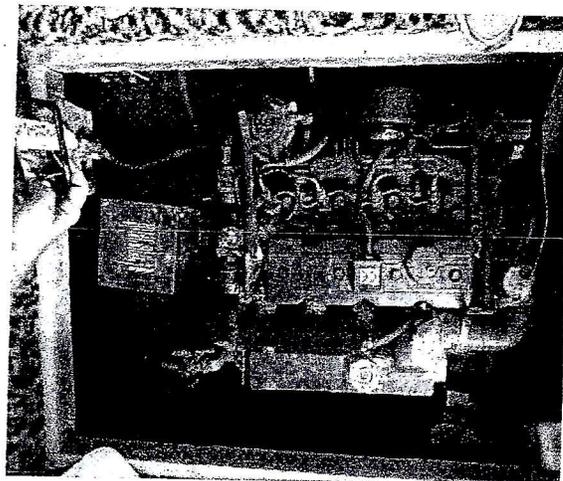
*Diesel generator control panel would not power up, diagnose and run generator for operation

Generator exhibited paint missing in many locations due to heavy corrosion,

***Generator primary fuel Racor bowl dirty. Perform complete generator service as outlined in manufacturers maintenance manual.**
